# THE STORY OF TWO BRIDGES: THE COLONNADE BRIDGE AND THE EAST BURKE STREET BRIDGE

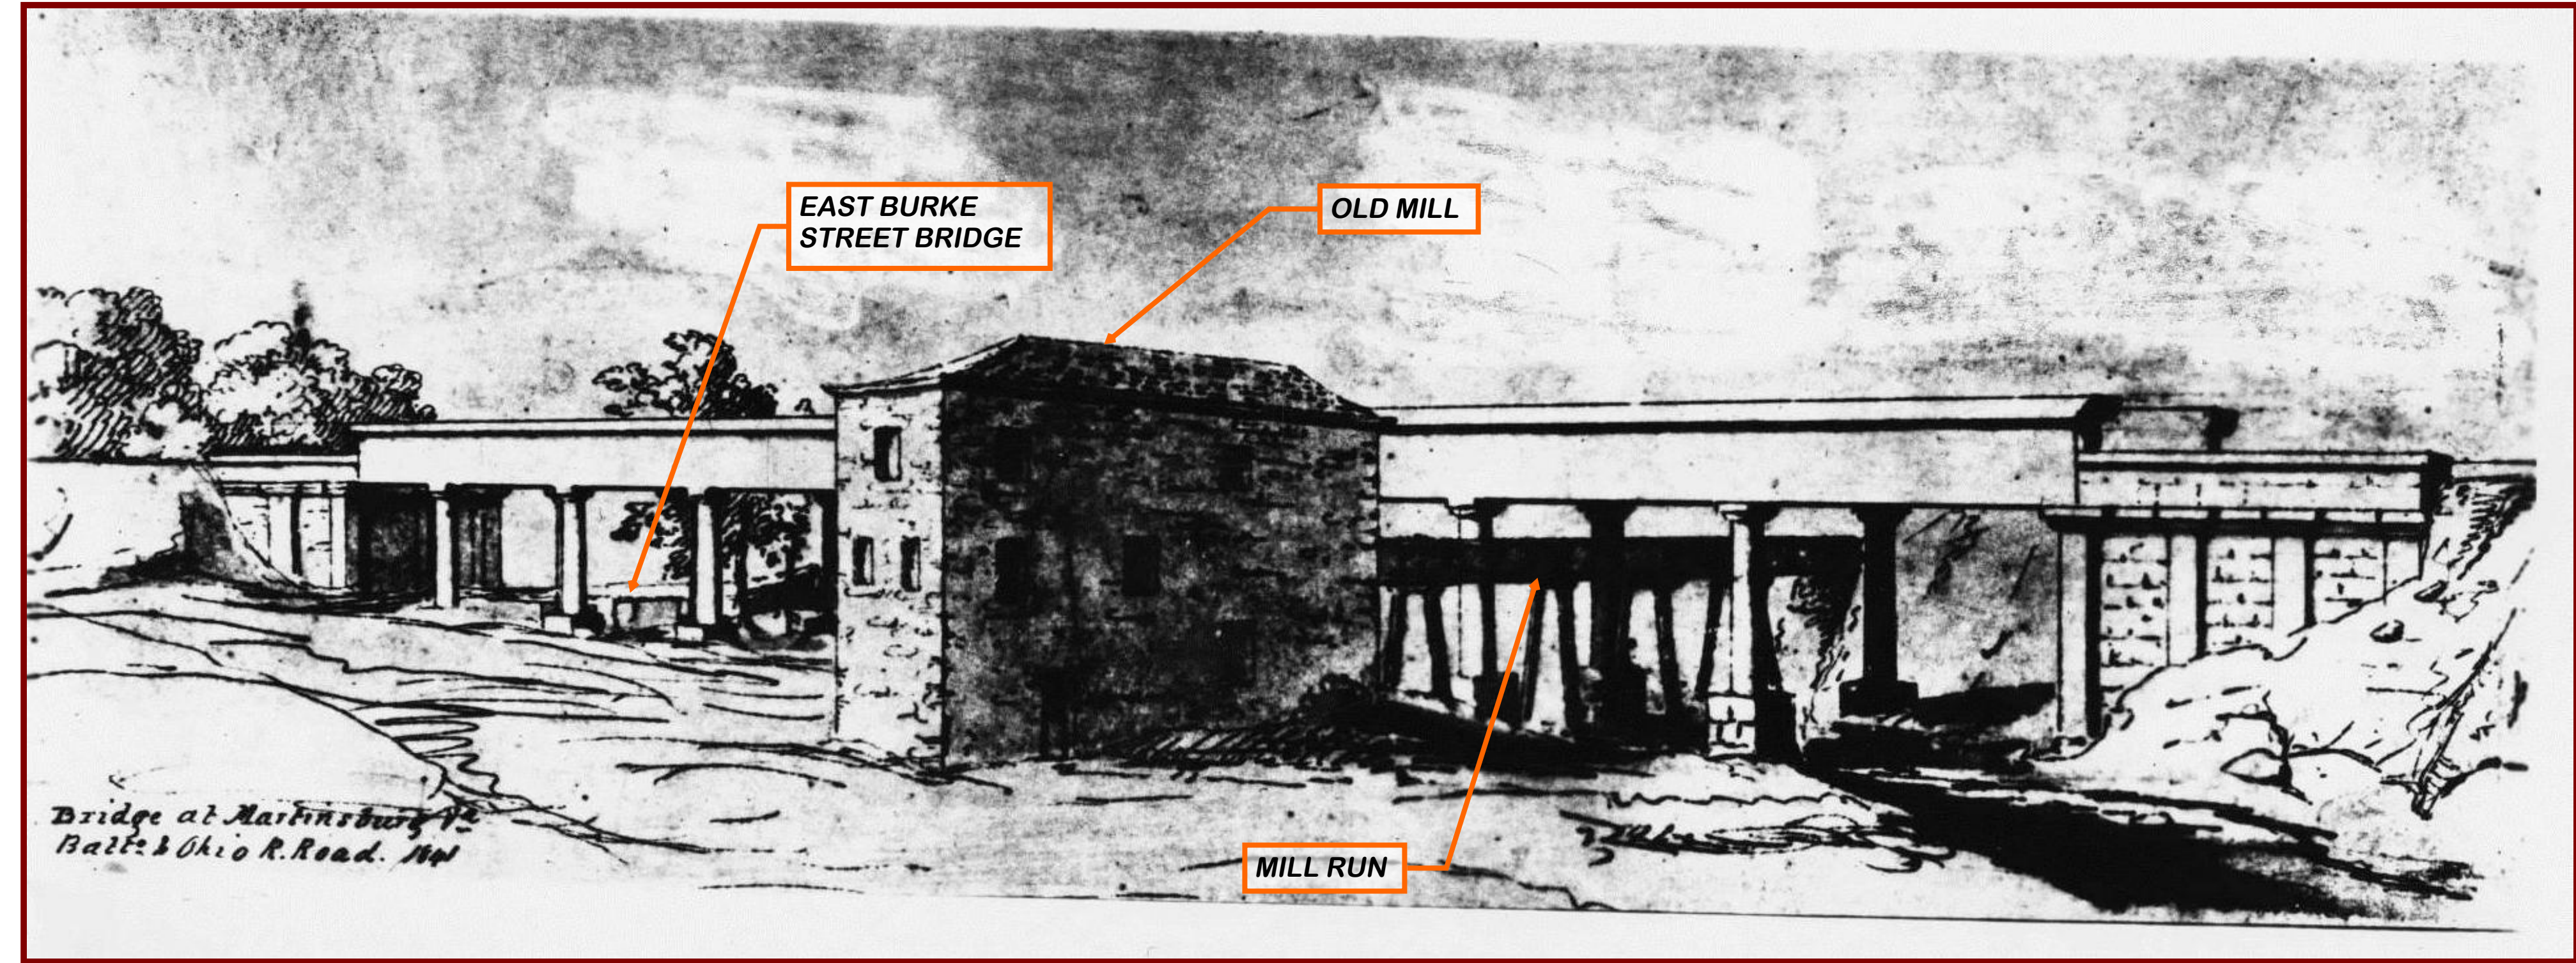
LOOKING UPSTREAM AND NORTHEAST AT THE COLONNADE BRIDGE, CIRCA 1860

In 1849, the Baltimore and Ohio established its railroad shops in Martinsburg and erected here two most noteworthy roundhouses and workshop buildings. The B&O erected a crossing on the Tuscarora River as a special complement to the city. The unique viaduct included ten 44’ spans, composed of iron and timber. The spans were supported on two abutments and 18 beautiful stone Doric columns. Not surprisingly, it was called the Colonnade or Pillar bridge. Note that the East Burke Street Bridge can be seen in the left background.

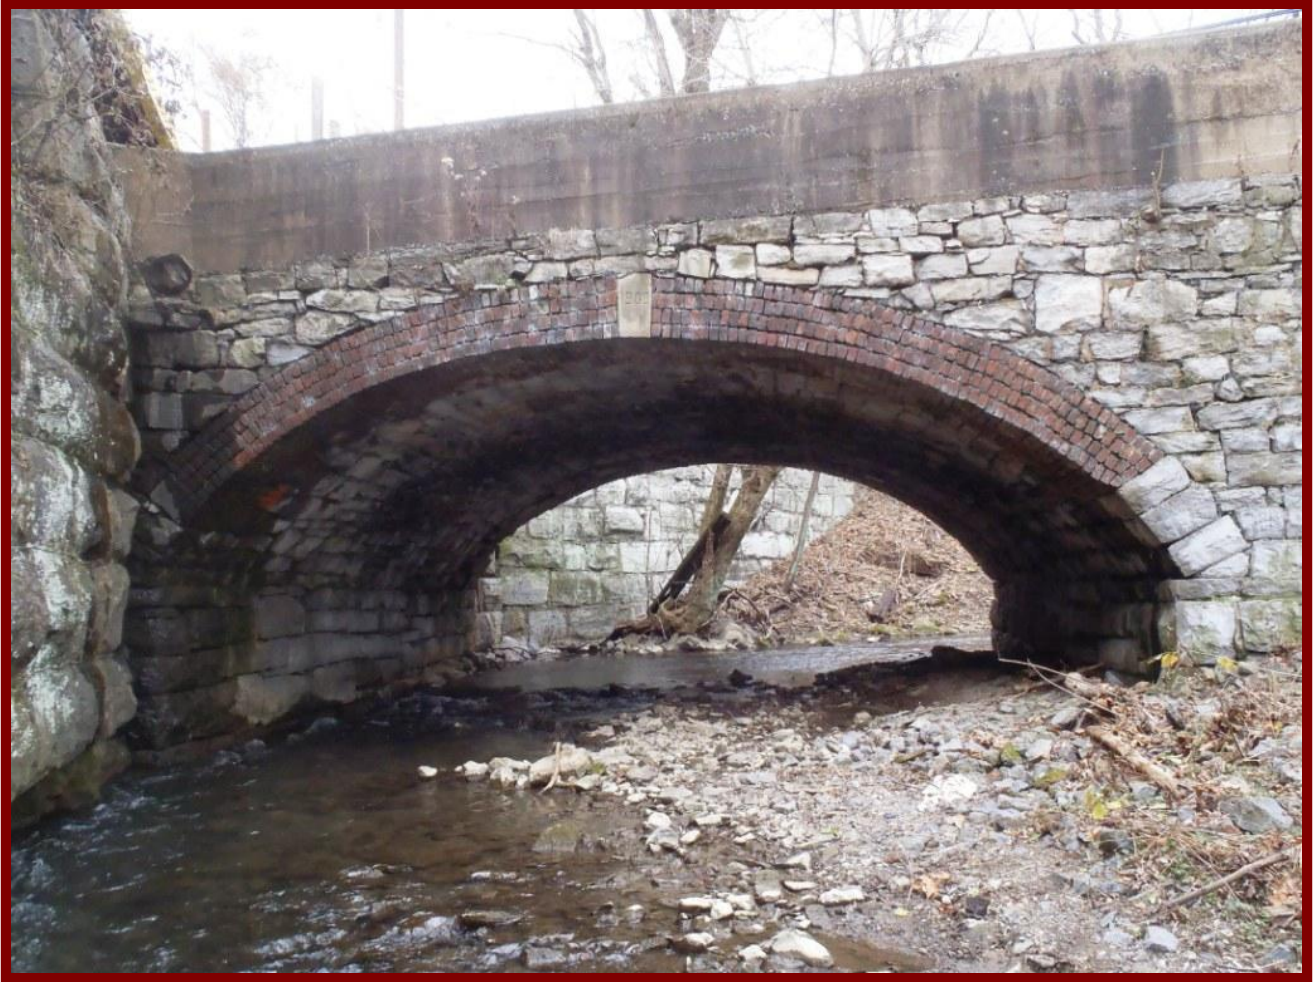
The East Burke Street Bridge was constructed as early as 1861. Near the turn of the century, the arch ring stones were replaced with brick. The downstream arch ring has a keystone bearing the date 1900. The arch was renovated in 2019. The City of Martinsburg and the West Virginia Department of Transportation consulted with engineers from Burgess & Niple to preserve the character of the original stone arch while increasing its load carrying capacity. The original stone arch barrel was topped with steel reinforced concrete. The walls are concrete with local limestone facings. Orders Construction Company completed the project for a cost of \$2.4 million.

LOOKING UPSTREAM AT EAST BURKE STREET BRIDGE CIRCA 2012 PRIOR TO RENOVATION

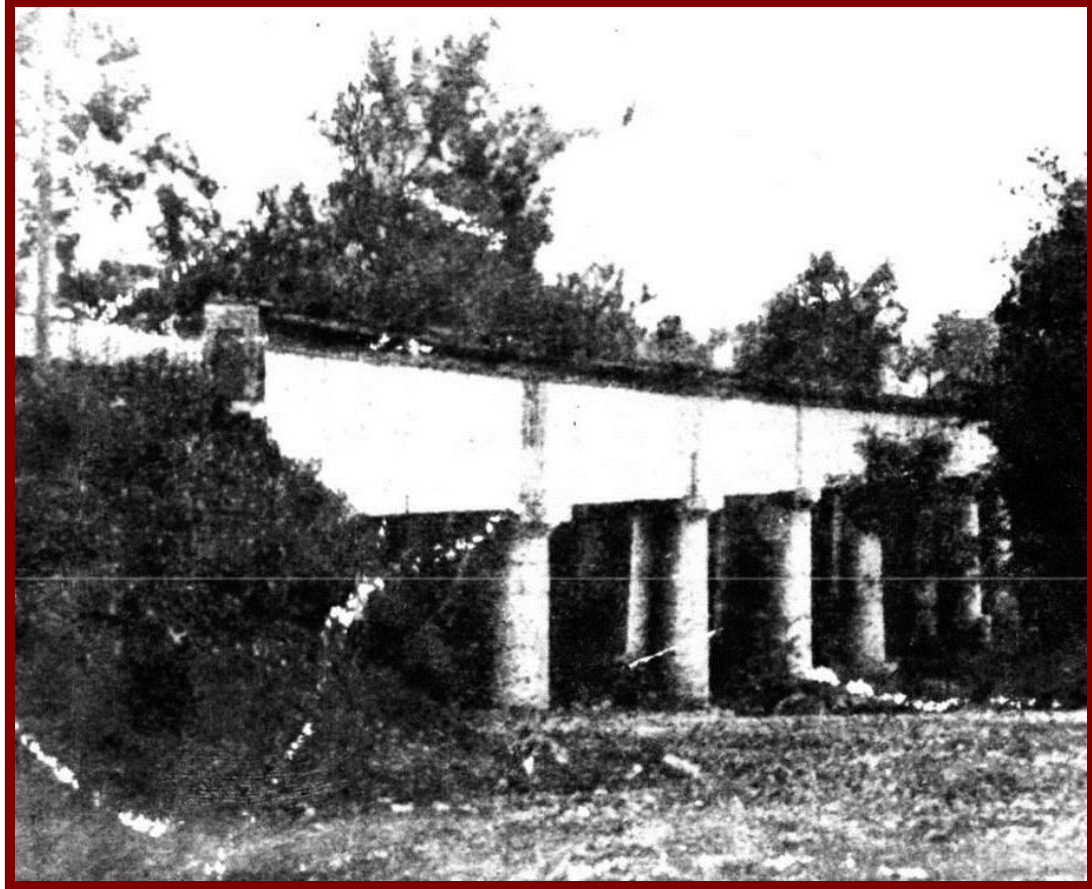
ONLY KNOWN PHOTO OF THE COLONNADE BRIDGE

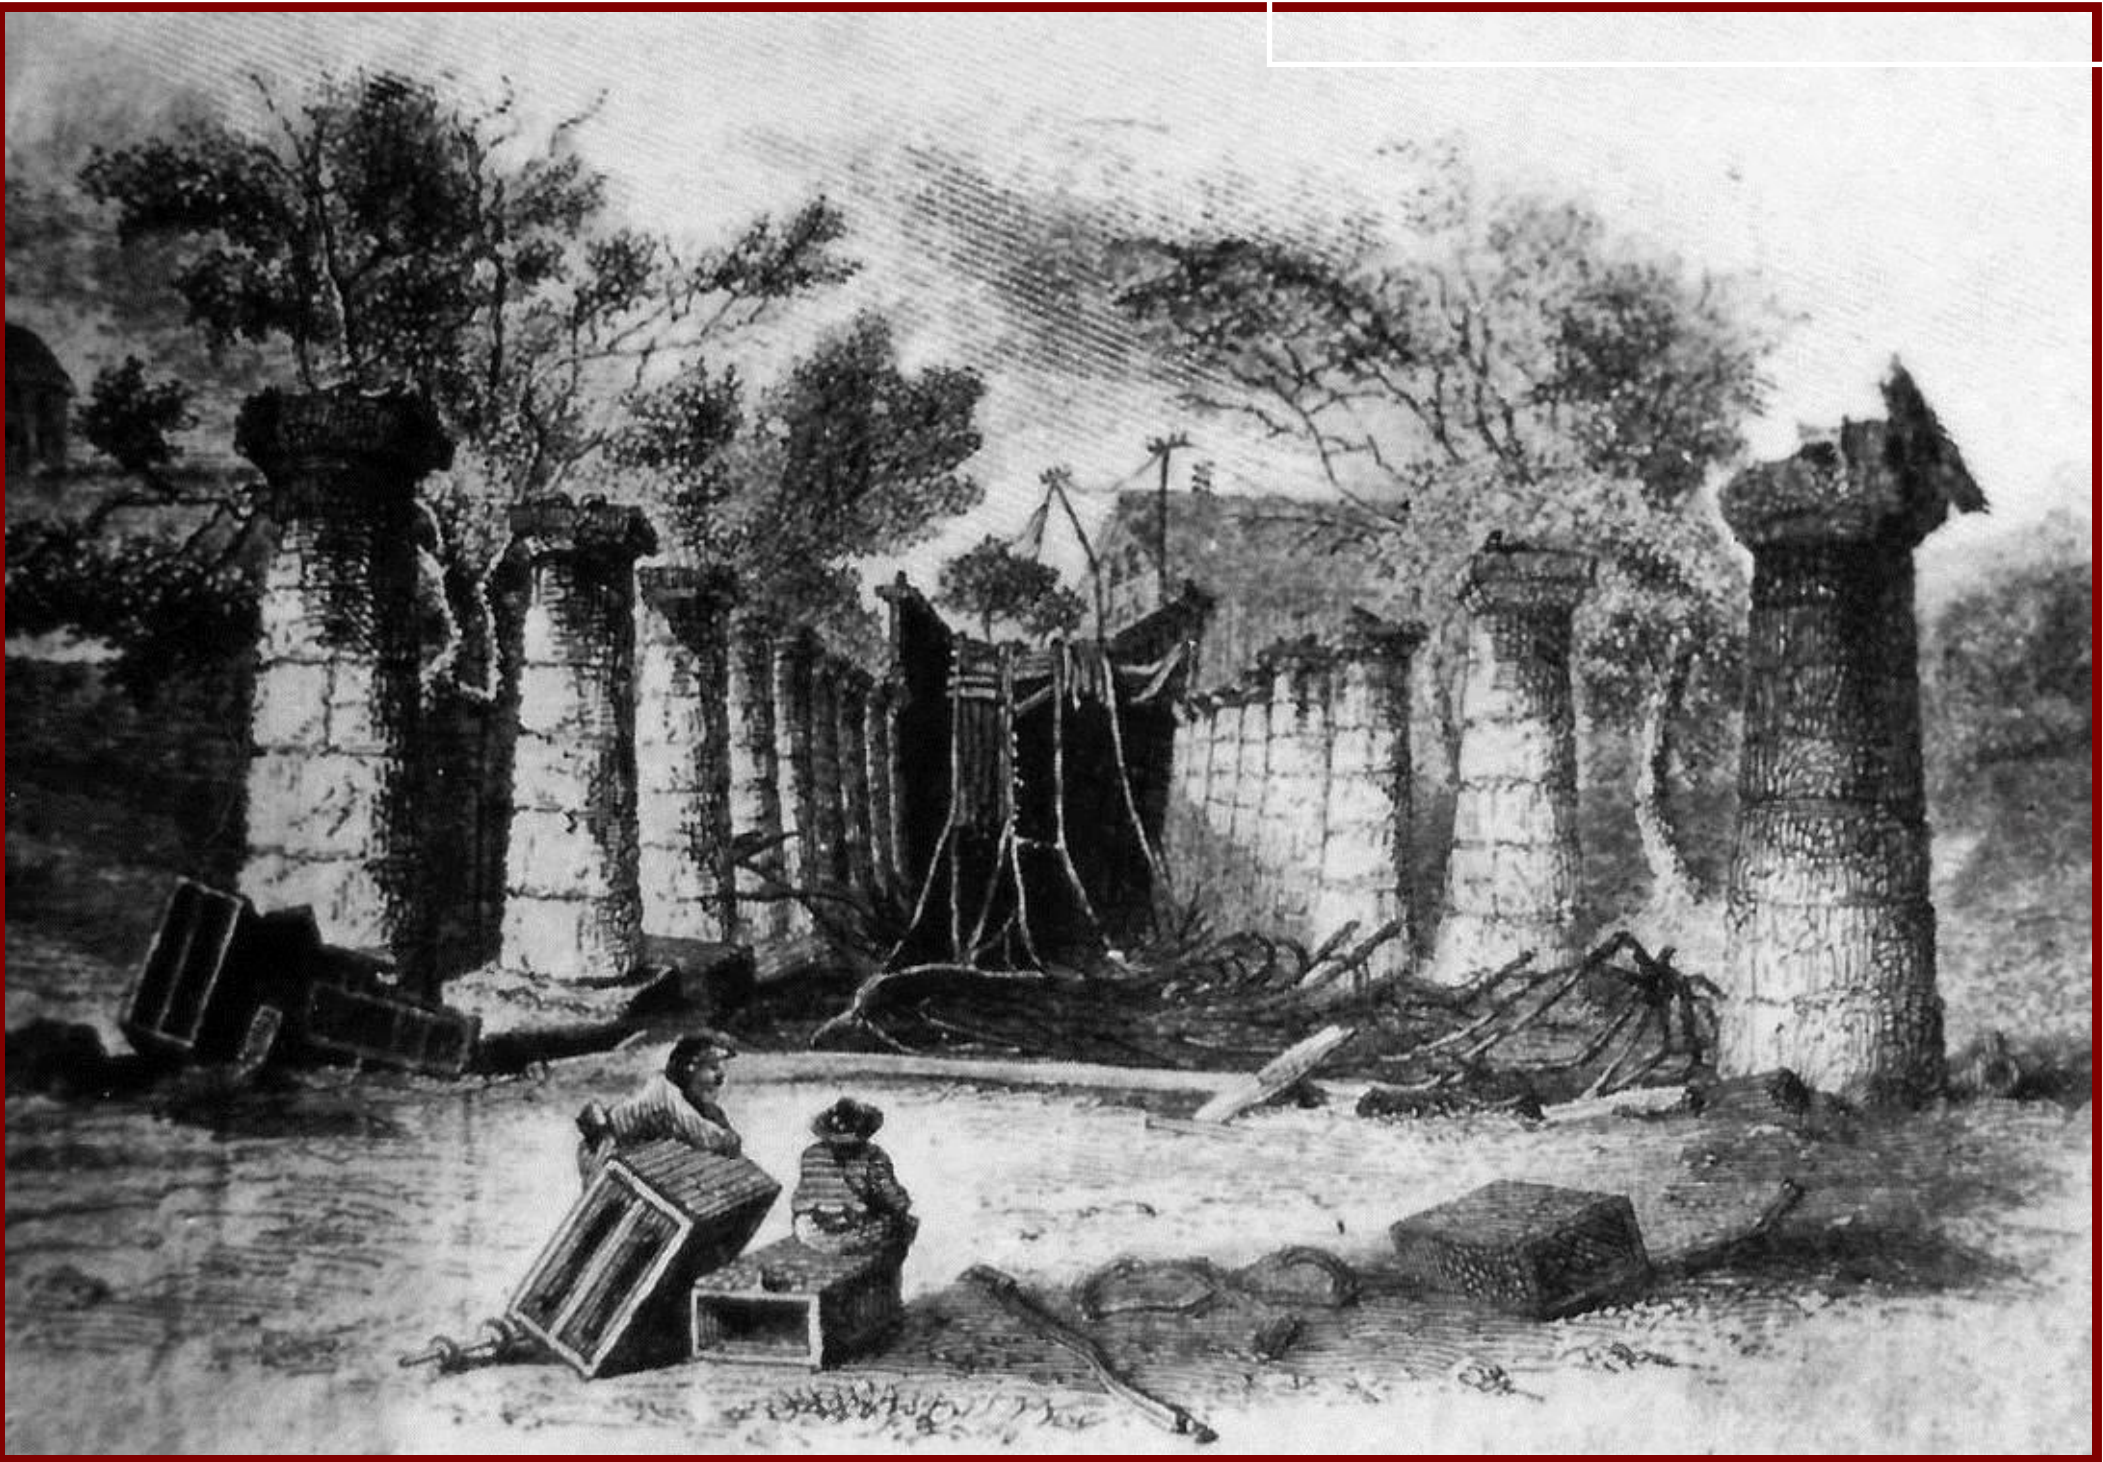
The artistic rendering below captures the devastation with only the melted rails and stone columns remaining of the once prominent structure.

RUINS OF THE VIADUCT
