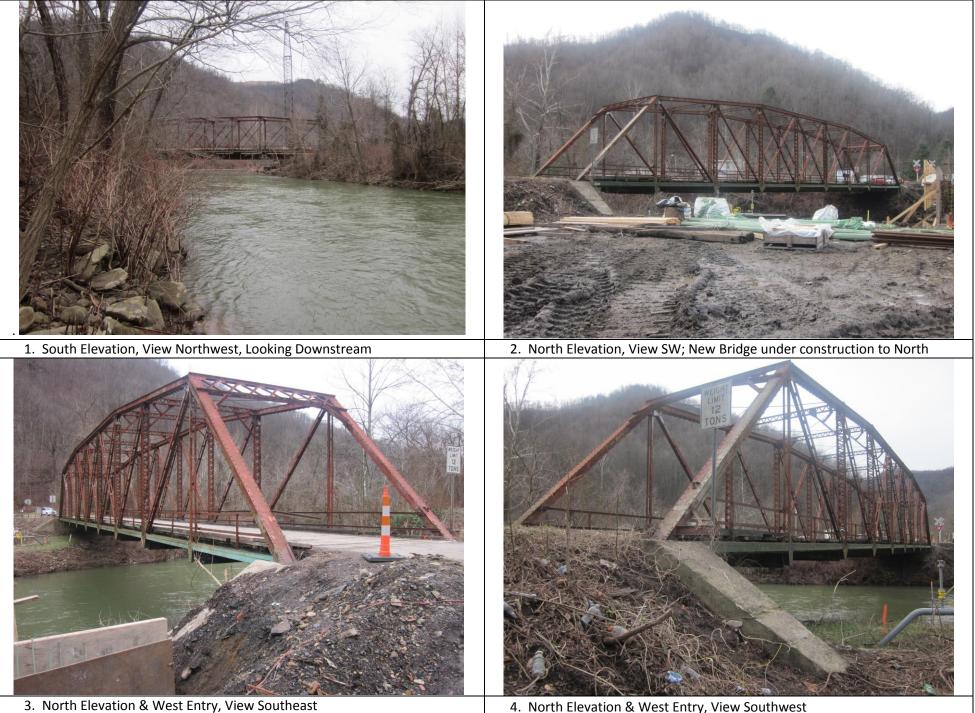
4. North Elevation & West Entry, View Southwest

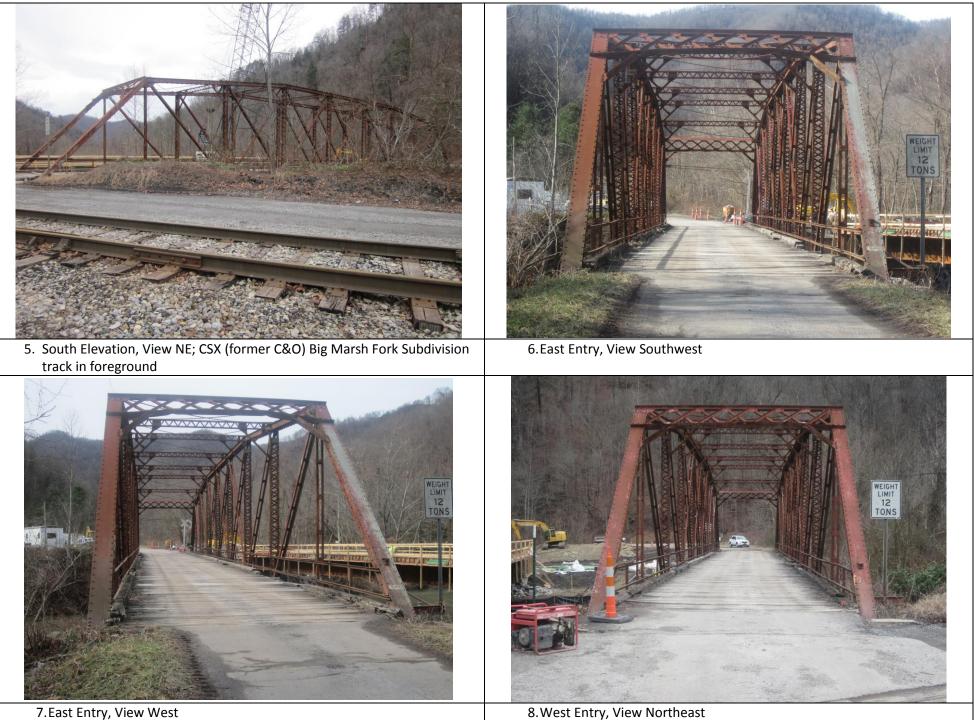
8. West Entry, View Northeast

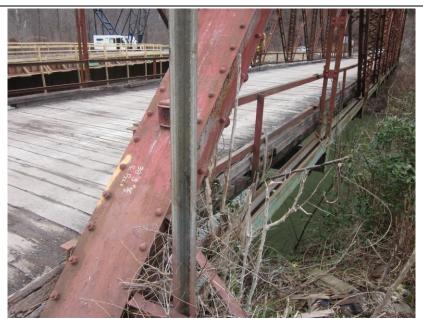
16. South Truss Showing Lower Chord (part that the vertical posts and diagonal bracing area gusseted to), View Northeast; Lower Chord composed of two original steel L-shapes, each topped by a steel L-shape installed in 1993.

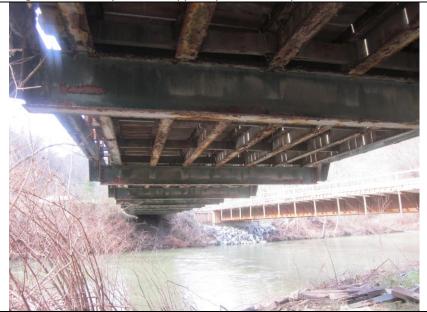
18. Underside of Bridge, View West/Southwest; Composed of steel floor beams, topped by steel stringers w. diaphragms (lateral bracing) between, top with wood nailing strips to which the wood deck boards are attached.

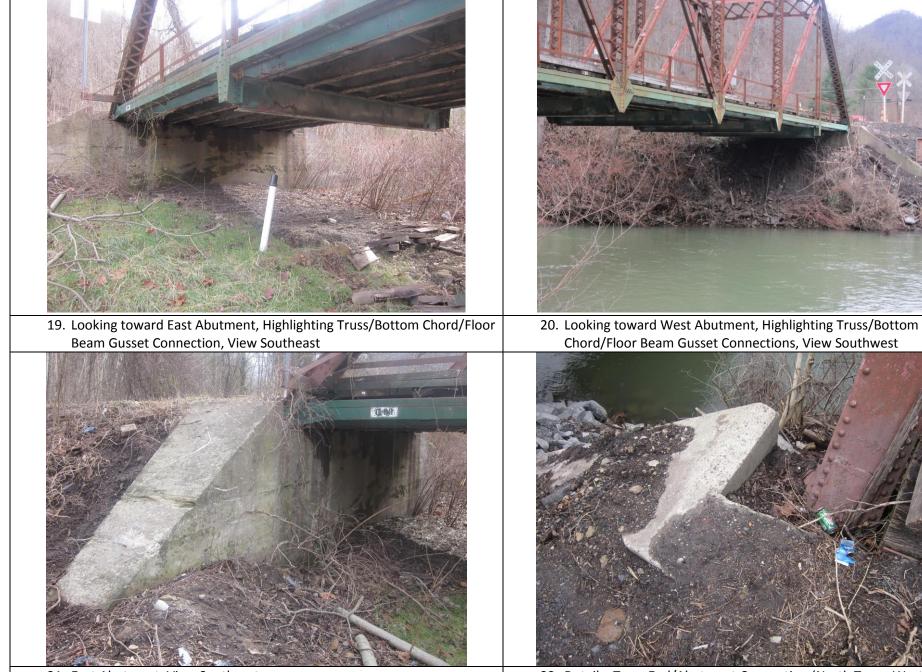
22. Detail – Truss End/Abutment Connection (North Truss, West End), View Northeast
